737-800 BCF

**STRUCTURAL REPAIR
MANUAL, RIGID CARGO
BARRIER**

DOCUMENT: VA-SRM-1000

Published by Ventura Aerospace, Incorporated, Westlake Village, California, USA
November 8, 2017

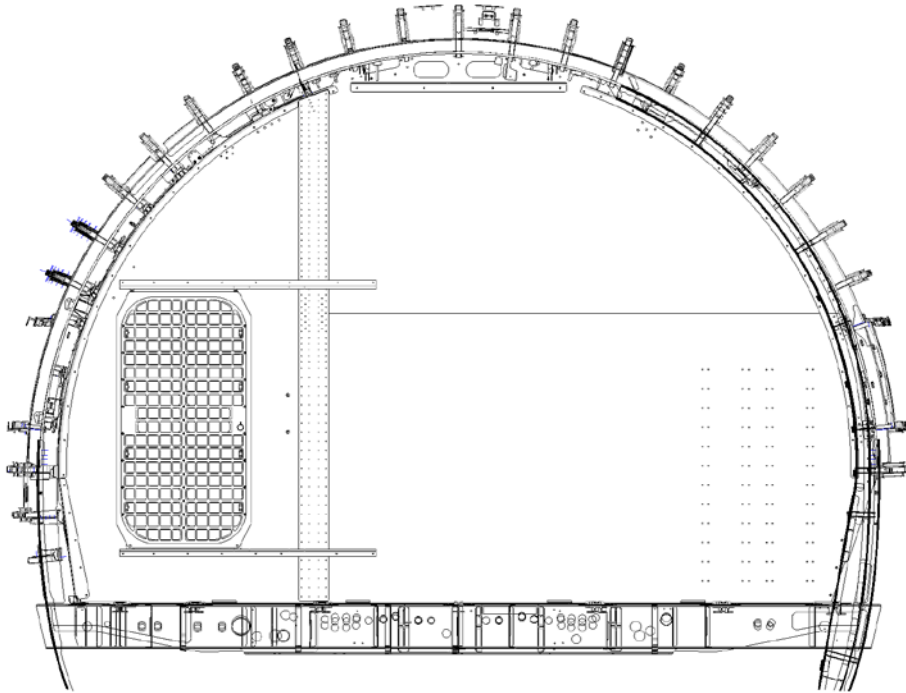
FIGURE 53-00-03-1: VIEW LOOKING FORWARD AT RCB

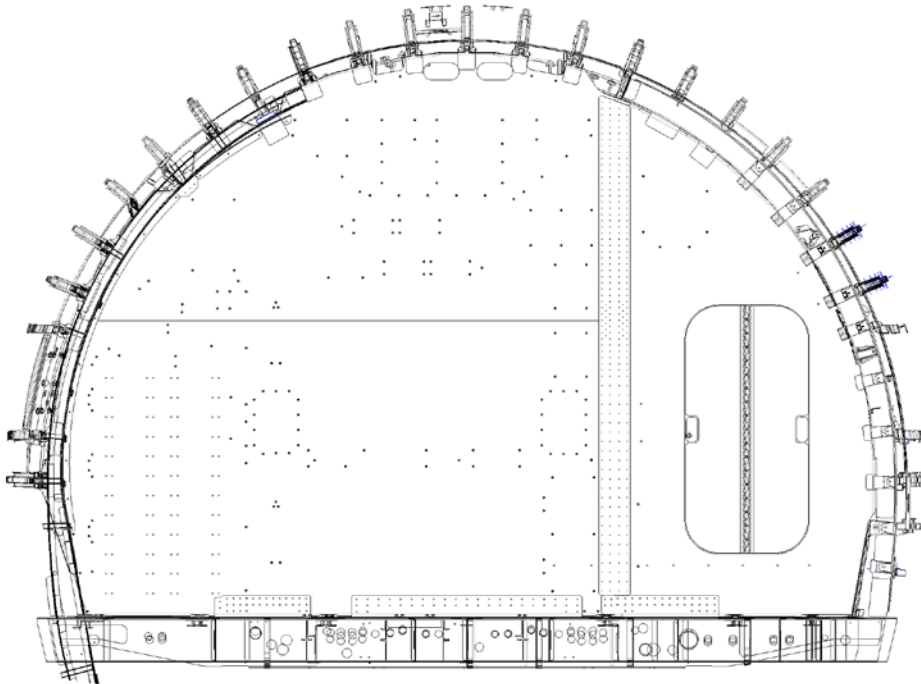
FIGURE 53-00-03-2: VIEW LOOKING FORWARD AT RCB

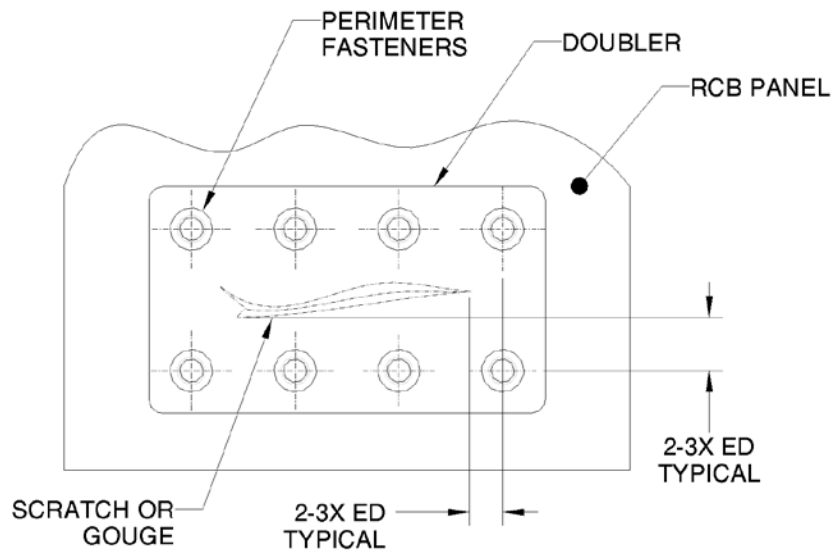
Figure, 53-20-10-1, Major Scratch and Gouge Repair

Install a .160 thick 7075-T6 Aluminum Doubler over the affected area in accordance with Figure 53-20-00-1 below. Remove all paint and clean the affected area of the scratch or gouge extending out at least 3.0 inches. Layout the Doubler shape by measuring 1.0 inch beyond the scratch or gouge. Allow for additional material for fasteners in accordance with notes in 53-30-00. After Doubler dimensions are determined and fastener holes are drilled, de-burr the Doubler. Apply Hysol EA9394 between the Doubler and the Barrier Panel. Install using CR3523-5-() Cherrymax Rivets (grip will vary based on barrier face sheet thickness at specific location). Alternate, through bolt using: NAS6204-() Bolts, NAS1149F0463P Washers and MS21042L4 Nuts. Minimum quantity of 4 fasteners required. The fastener pitch is to be no greater than 1.5" spacing CL to CL. If the repair is restricted by adjacent components a unique repair is required, contact Ventura Aerospace, Inc. for engineering disposition.

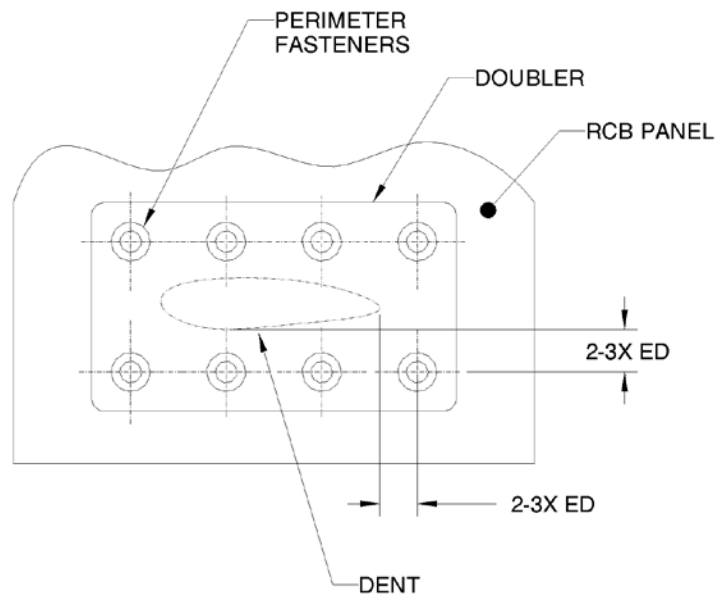
Figure, 53-20-10-2, Major Dent Repair

Install a .160 thick 7075-T6 Aluminum Doubler over the affected area in accordance with Figure 53-00-21-2 below. Remove all paint and clean the affected area of the dent extending out at least 3.0 inches. Layout the Doubler shape by measuring 1.0 inch beyond the dent. Allow for additional material for fasteners in accordance with notes in 53-30-00 REPAIR NOTES. After Doubler dimensions are determined and fastener holes are drilled, de-burr the Doubler. Apply Hysol EA9394 between the Doubler and the Barrier Panel. Install using CR3523-5-(XX) Cherrymax Rivets (grip will vary based on barrier face sheet thickness at specific location). Alternately, you may through bolt using: NAS6204-(84) Bolts, NAS1149F0463P Washers and MS21042L4 Nuts. Minimum quantity of 4 fasteners required. The fastener pitch is to be no greater than 1.5" spacing CL to CL. If the repair is restricted by adjacent components, a unique repair is required, contact Ventura Aerospace for engineering disposition. Dents greater than .10 deep and covering an area greater than 4.0 in² require the replacement of the RCB panel.
